3311 Madera Avenue, Oakland, CA 94619

SUGGESTED IMPROVEMENTS
3311 MADERA AVENUE
OAKLAND, CALIFORNIA

WOOD DESTROYING PESTS AND ORGANISMS INSPECTION REPORT

BUILDING NO. 3311	STREET, CITY, STATE, ZIP MADERA AVENUE, OAKLAND CA 94619	Date of Inspection 6/16/2009	No. of Pages 8
-----------------------------	--	--	--------------------------

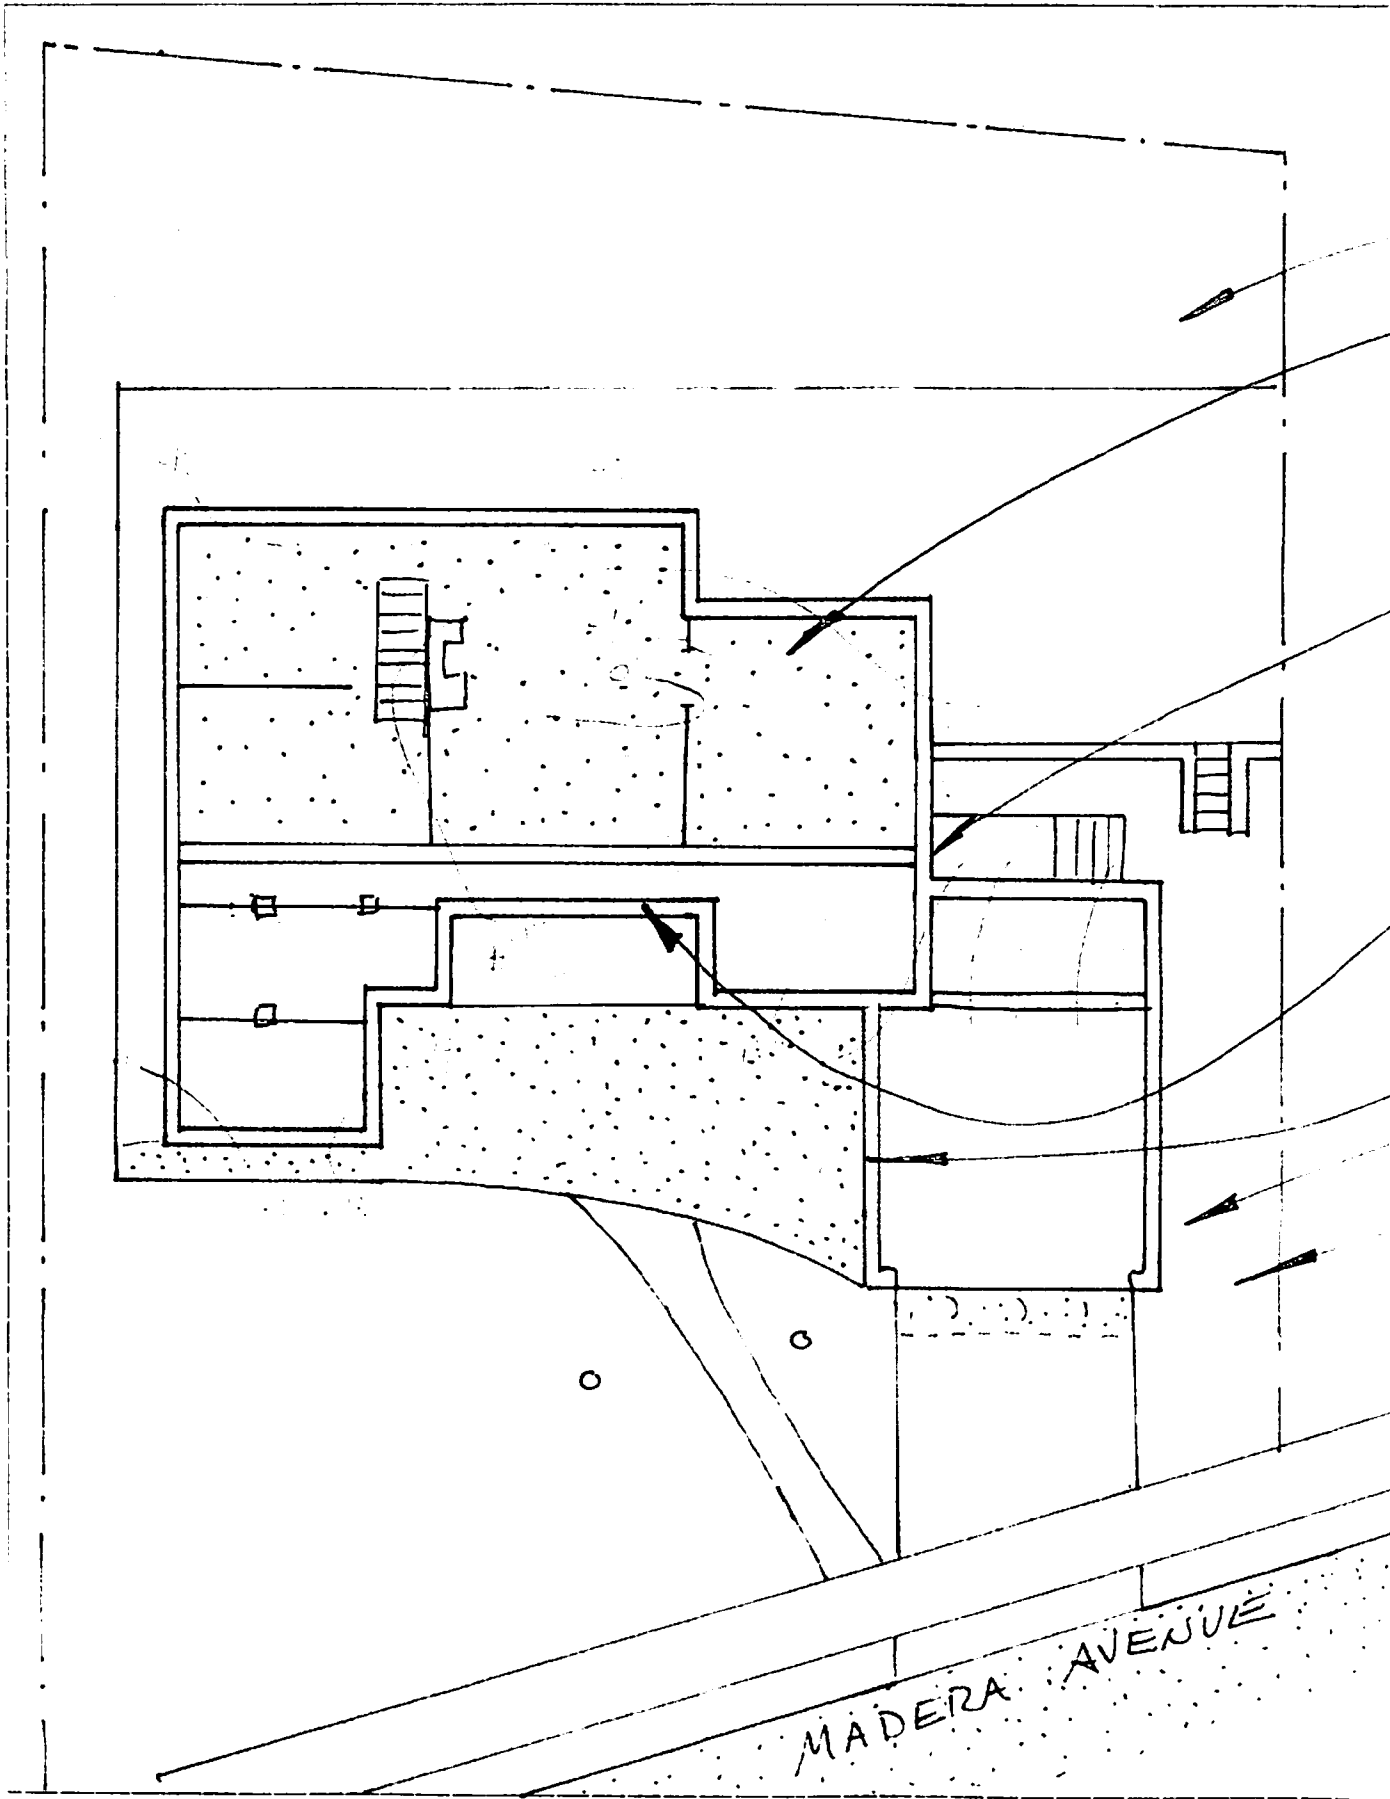
OBSERVATIONS: The basement floor slab is significantly heaved, such that the rear edge has lifted away from the foundation about 1 inch. Some minor settlement and rotation may have also occurred in the rear foundation. The front and rear patios, the driveway and the garage slab are also severely distressed. Despite the movement in the slabs, the foundations themselves are relatively free from distress, which may indicate that they are reinforced. I noted that the front foundation wall is slightly undermined in the vicinity of the front entry.

During my examination a floor level survey was performed at the upper level of the house. This survey found a localized high area at the center of the house. Relative to this high point the floors slope approximately 1.5 inches toward the rear perimeter, approximately 1.5 inches toward the front bedroom, and approximately 3 inches toward the laundry area behind the garage. In general the floor slope is not too bad for an old house on shallow footings. The pattern of the level contours (high in the center and low at the perimeters) suggests that the bulk of the movement is related to differential swelling of expansive clay soils. It appears that the center of the house has risen, while minor settlement may be taking place along the perimeter. The recent changes are probably a result of deeper drying following a winter with lower than normal rainfall.

The drainage conditions at the property are poor. The ground surface in the front yard slopes toward the house and there are few provisions on site for the control of drainage. You have observed seepage into the basement (passing over or through the center foundation wall) and the perimeter foundations are marked with efflorescence (evaporative salt deposits). Seasonal moisture intrusion is likely exacerbating the expansive soil movement.

CONSIDER REMOVING AND REPLACING BASEMENT FLOOR SLAB, LOWERING HIGH AREA AT CENTER. NEW SLAB SHOULD BE 5" THICK WITH #4 BARS @ 18" O.C.E.W., EPOXY DOUGLED TO PERIMETER FOUNDATIONS. THOROUGHLY SATURATE SUBGRADE FOR 72 HOURS PRIOR TO POURING SLAB.

OPTIONAL SECONDARY GRAVEL DRAIN BEHIND UP-SLOPE FOUNDATION WALL OF BASEMENT. INSTALL THIS DRAIN IF PRIMARY DRAIN AT FRONT PERIMETER FAILS TO STOP BASEMENT SEEPAGE.

CAST 6"-THICK "RAT SLAB" BELOW FRONT ENTRY TO BRACE UNDERMINED FRONT FOUNDATION WALL. REINFORCE WITH #4 BARS @ 18" O.C.E.W. EPOXY DOUGLED INTO ADJACENT FOUNDATION WALLS.

REPLACE FRONT PATIO SLOPED TO TWO OR MORE U-1 CHRISTY BOXES.
